THE UNITED STATES  
STRATEGIC BOMBING SURVEY

SUBMARINE ASSEMBLY  
SHELTER  
FARGE, GERMANY

MUNITIONS DIVISION

**SUBMARINE ASSEMBLY SHELTER AT FARGE**

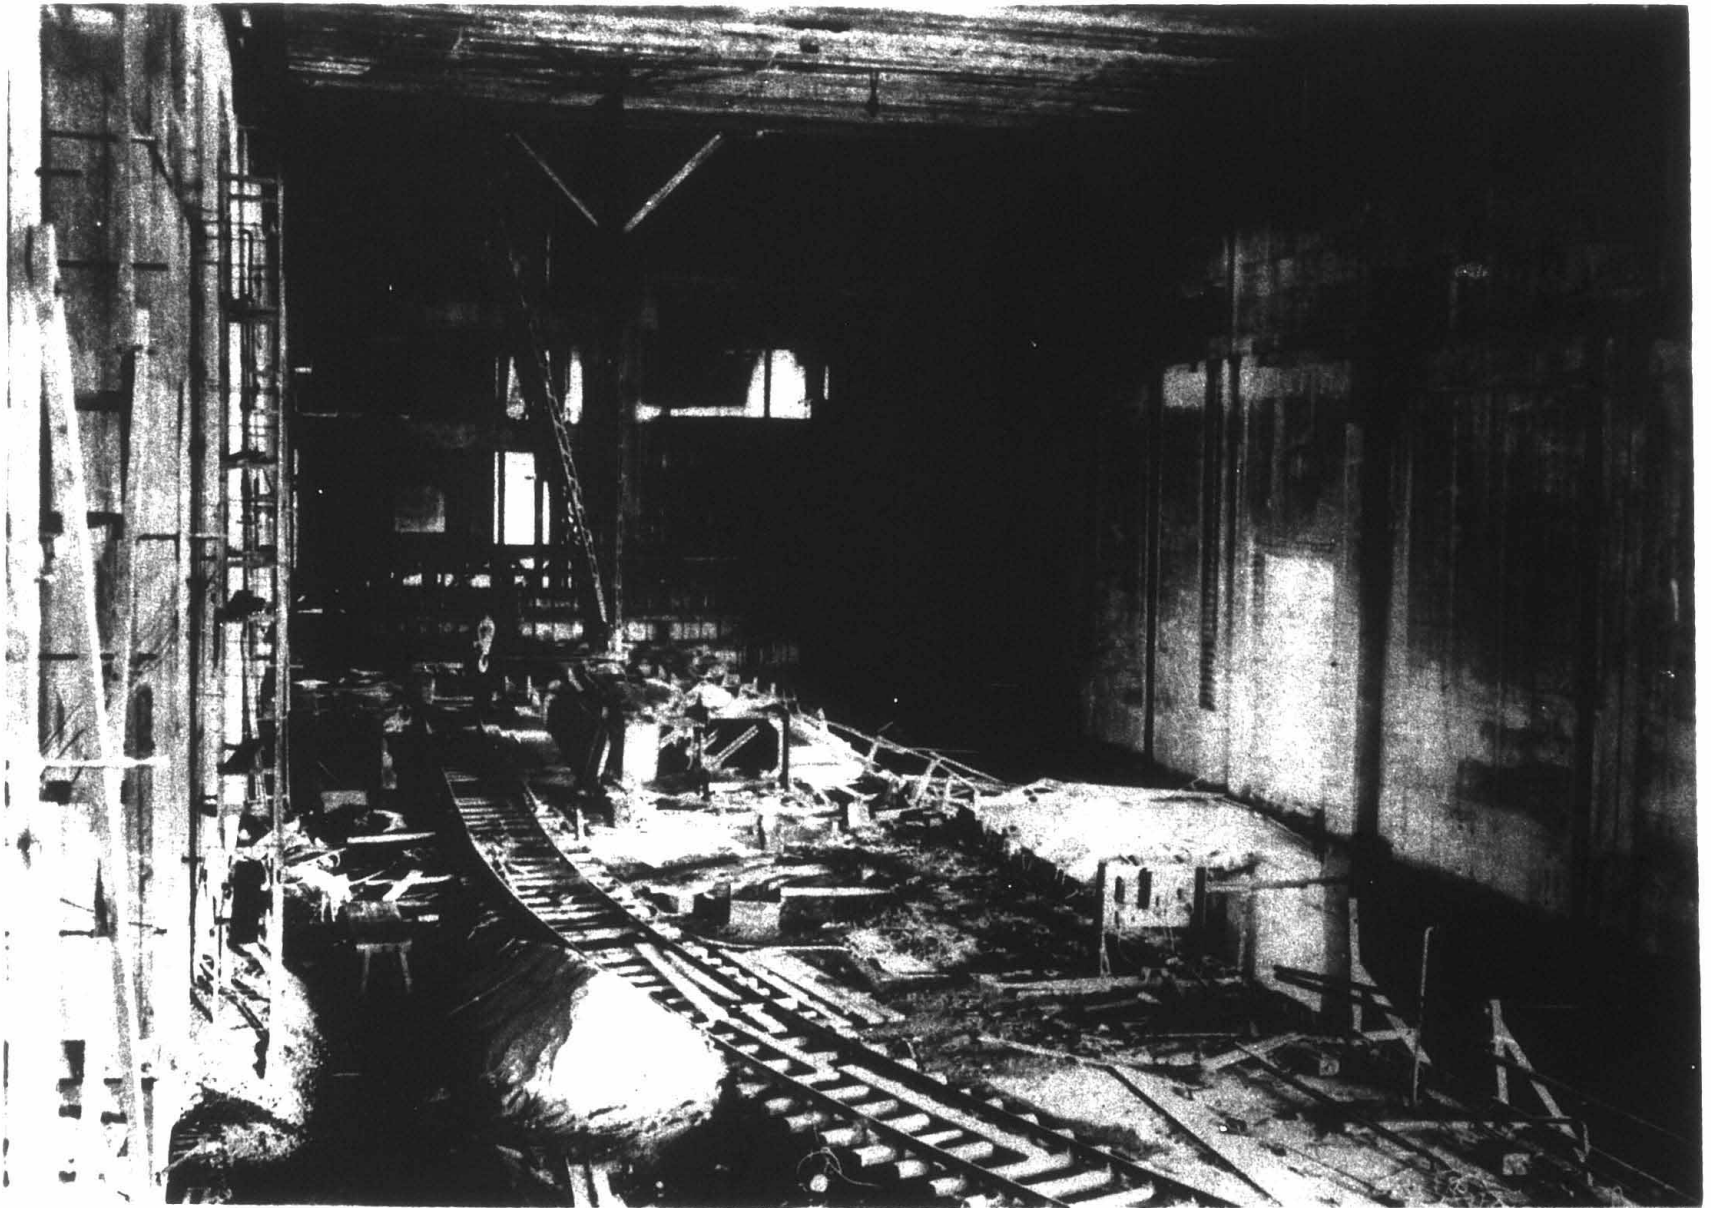
Interior view showing positions 12 and 13 at NW corner of building indicating water tight gates to allow flooding of position 12.

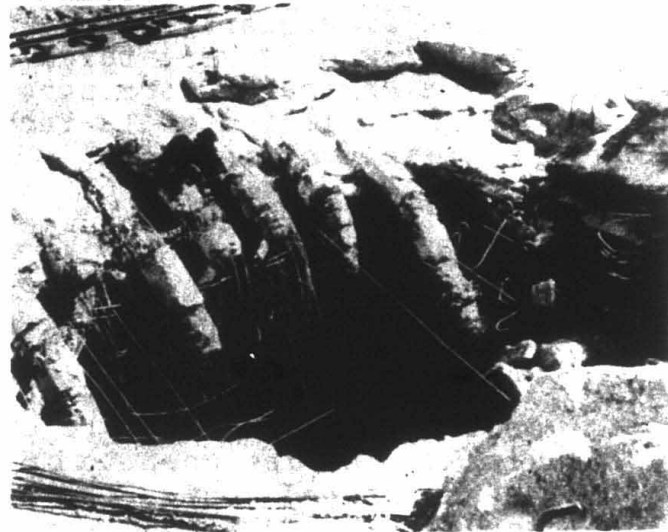
Photo 4 - View of crater no. 4.

c. Only a few reinforcement rods at the top of the slab were blown upward, the remainder being blown downwards. (Photo 4)

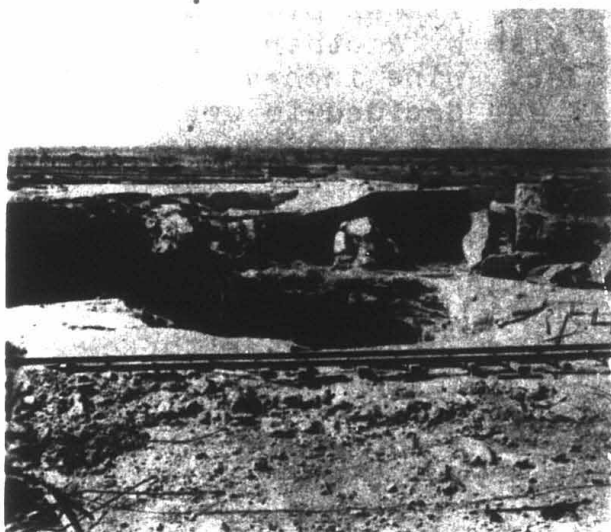
Photo 5 - View of crater no 16 from N, showing spalling cracks in the step.

d. The concrete of the 14 feet, nine inches slab shows spalling cracks directed downward, whilst the eight feet three inches high "step" (additional layer of concrete) next to the crater shows spalling crack running upwards. (Photo 5)

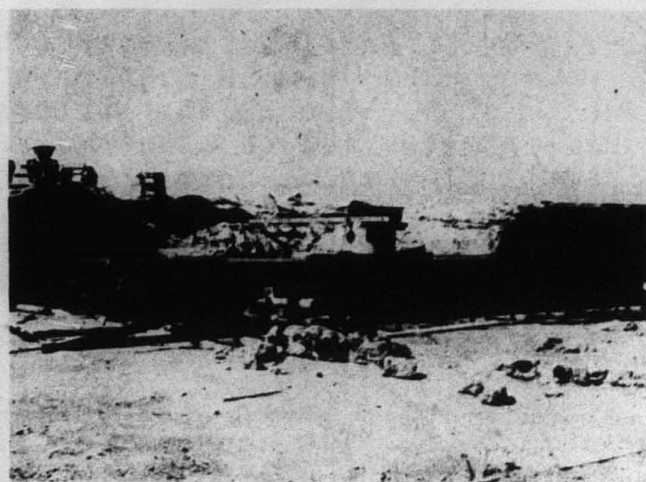
Photo 8 - View of crater no 15 (covered with joists) Steel girders over crater no. 15.

f. Crater 15, much the same as crater 16 in shape and dimensions, was covered by heavy steel "I" sections on the date of survey, and the Germans were planning to repair the eight damaged arched trusses. (Photos 8 and 9) Size of sections was 39 inches high, 12 inches wide, web flange one and three-eighths inches thick. German standard size "1-100".

h. The debris knocked down two travelling cranes. It is reported that the crane operator standing at that time on the adjacent crane escaped injury; this can be taken as a proof that the blast did not penetrate inside the building. (Photo 8)

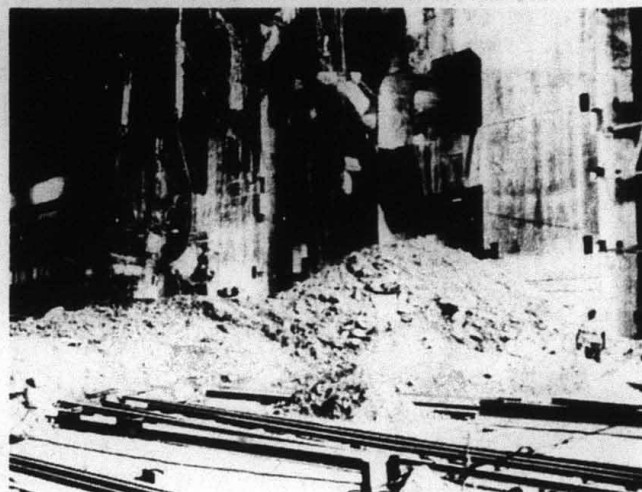
Photo 10 - Debris on floor underneath crater no 15.

g. The explosion brought down a considerable mass of concrete. (Photo 10) It weighs approximately 800 tons per crater. Numerous splinters were found inside and on the roof of VALENTIN, most of them being two inches thick. (photo 11) A general view of the damage can be clearly seen in Photo 12.

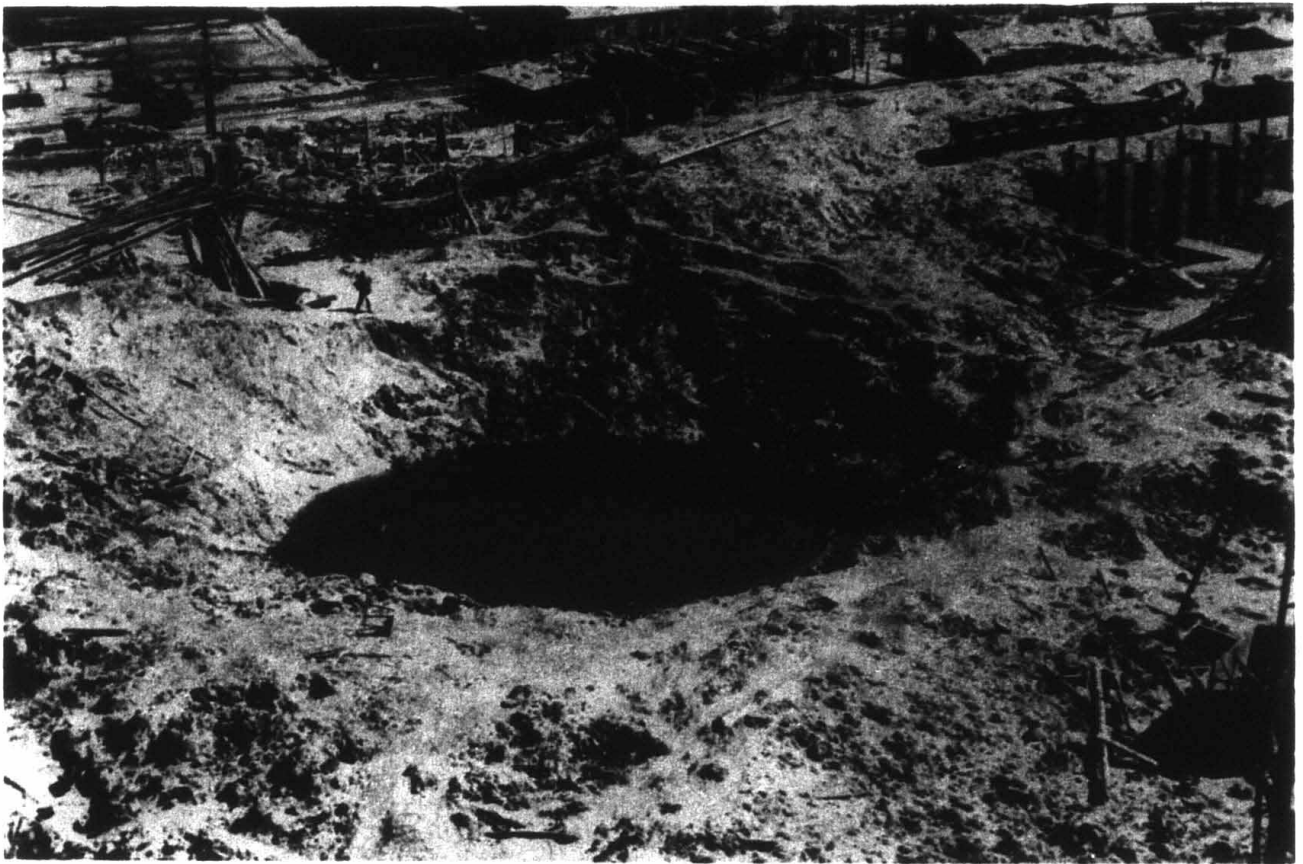
Photo 13 - View of crater 5 taken from top of VALENTIN looking north.

- (2) destroyed shed in vicinity of the eastern mixer battery
- (3) destroyed storage sheds between the eastern and western mixer batteries.  
(Photo 13 depicting crater 5)

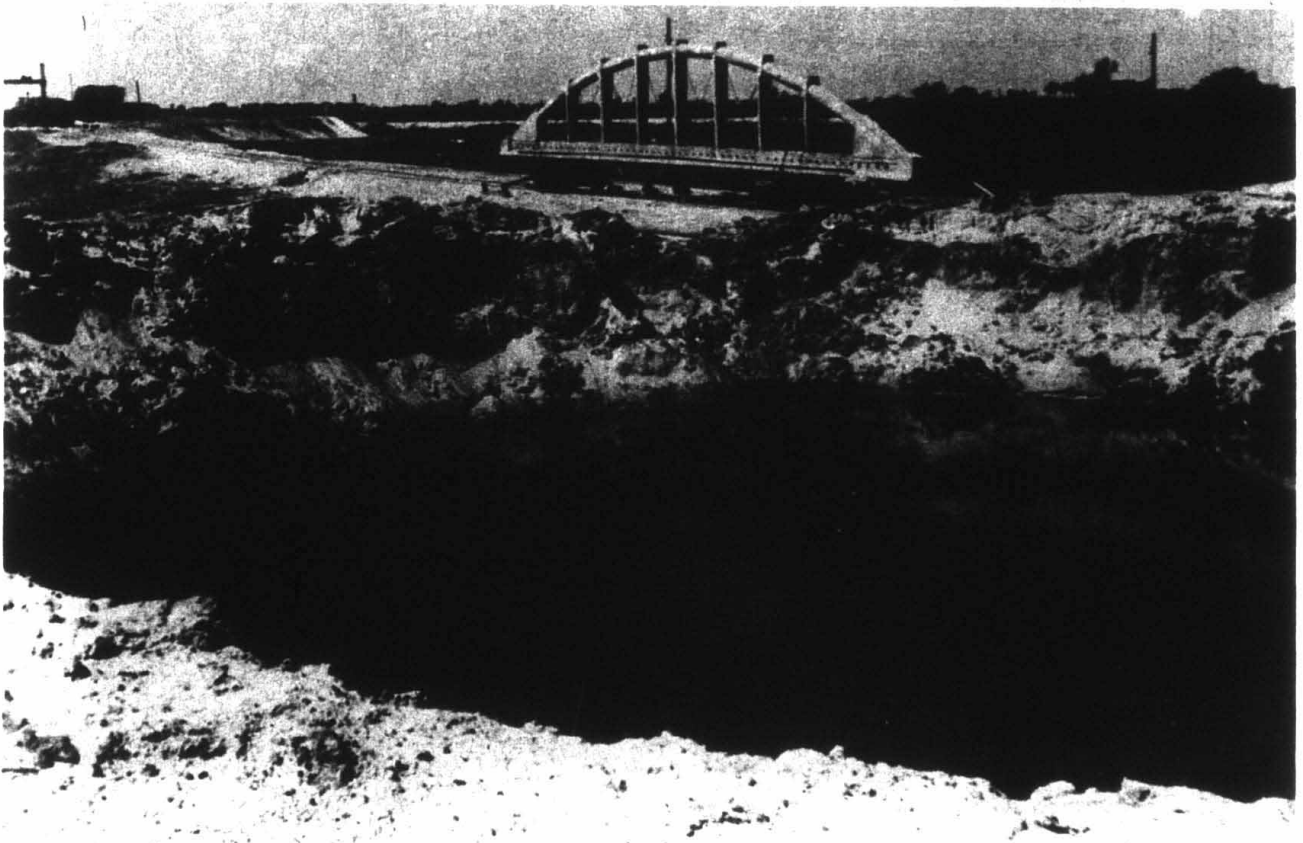
Photo 14 - View of crater 13 from southwest showing

- (5) damaged reinforcement bending plant by direct hits, bombs 10 and 11
- (6) severed the main rail line at crater 3
- (7) made the biggest crater, No 13, caused by a hit next to the arched trusses pre-fabricating plant (see Photos 14 and 15); this bomb displaced and upset numerous ready arched trusses, and destroyed the gantry which ran above the plant (see Photos 16, 17 and 18); the second gantry, undamaged, can be seen on Photo 18.

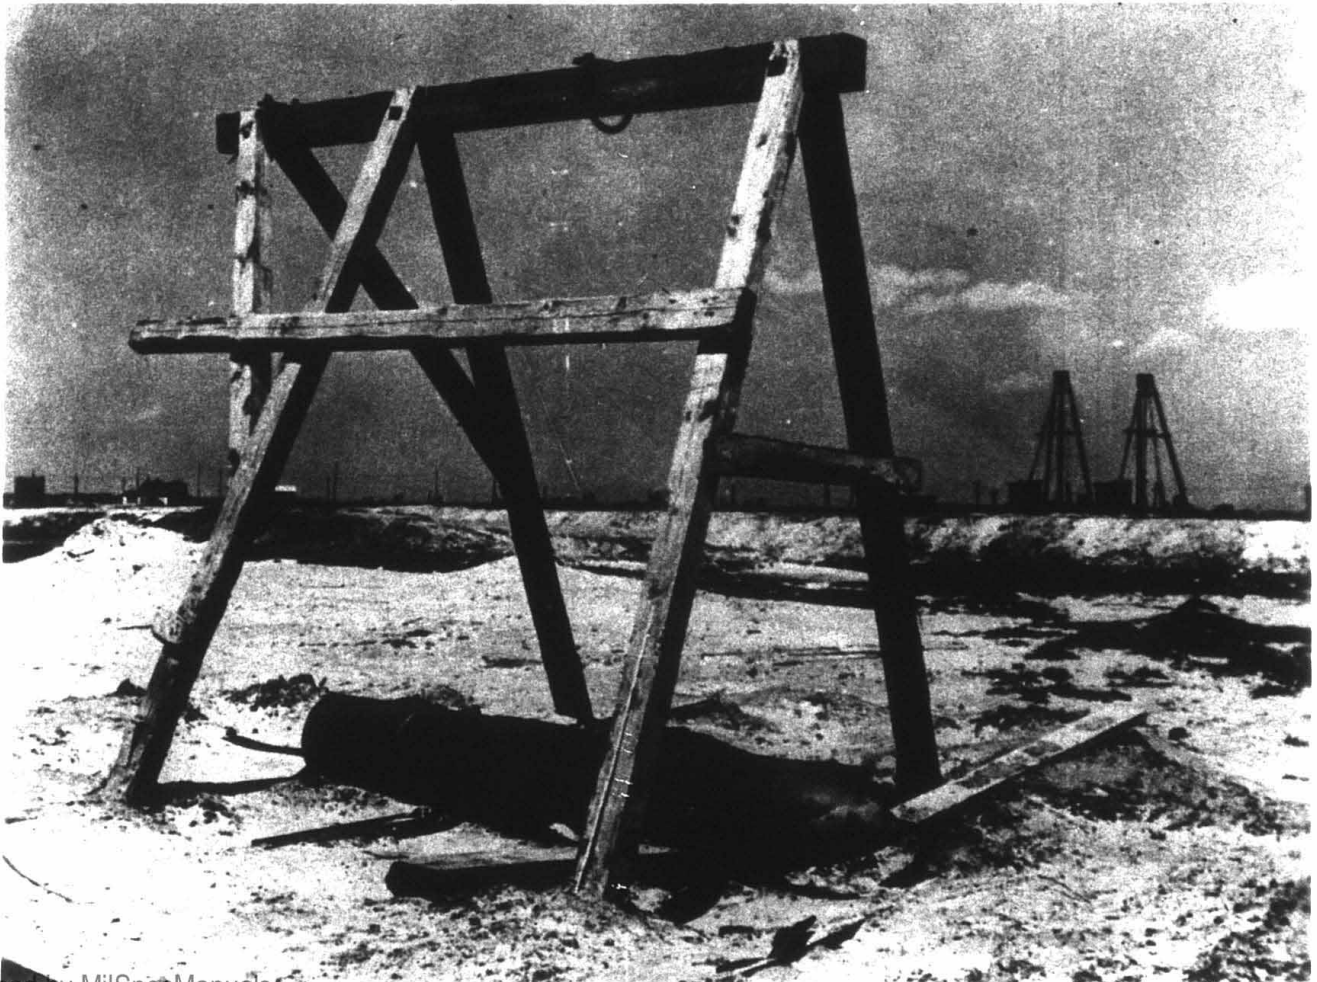
Photo 19 - UXB 4,500-lb. RA SP bomb.

- (9) Several camuflet Type C craters of the 4,500 lb RA/SP bombs were made around the SW end of VALENTIN, but no visible damage can be seen; one UXB, a 4,500 lb RA/SP, can be seen on Photo 19.
- (10) The floating dredge used for excavating the shore in front of VALENTIN was hit in the raid of 27 March 1945, and sank.

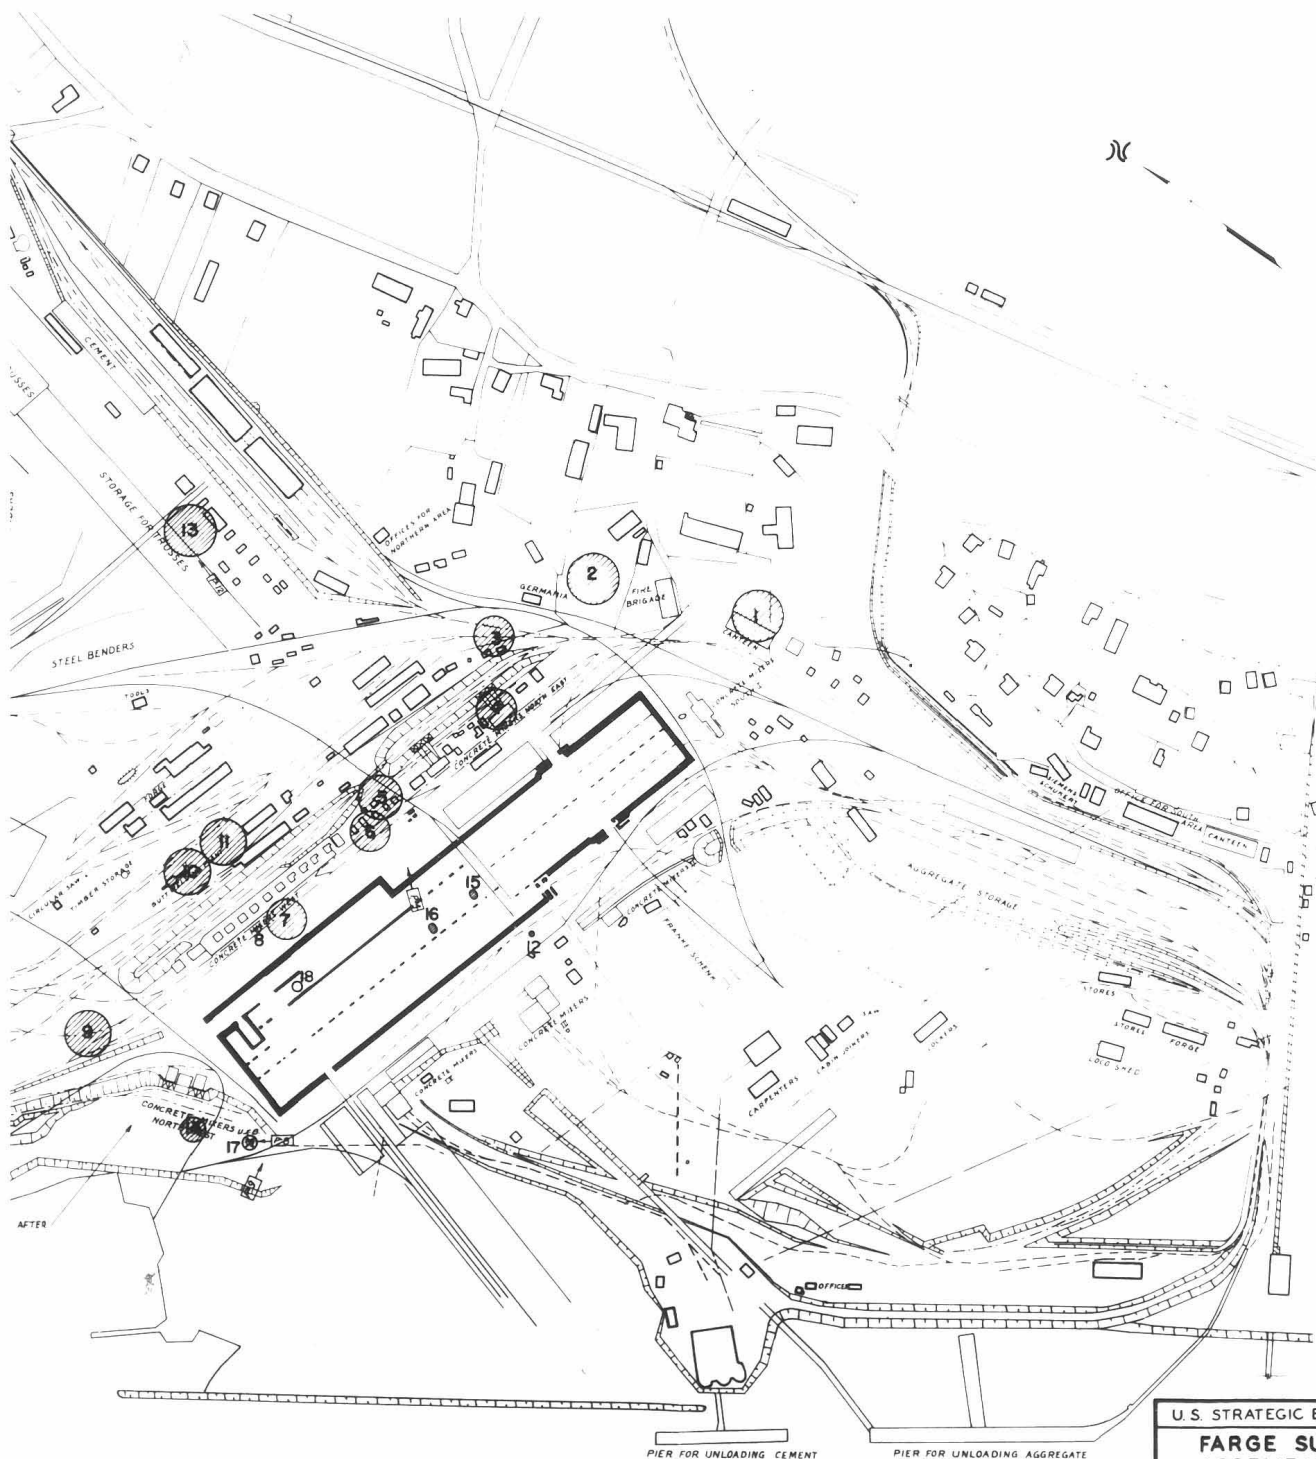
**GENERAL LAYOUT AND BOMB PLOT**

craters 15 and 16. (Exhibits A and E)

i. Crater 18 (Exhibit A) is probably due to a

4,500-lb RA/SP or "Disney" bomb, since air coverage photos reveal, and Germans confirm, that it is a result of the raid of 30 March 1945. It measures eight feet nine inches in diameter and is about two feet five inches deep. Numerous small fragments, some 1/8 inch and some one inch thick, were found around this crater. Most fragments were not, or were only partly, sheared at a 45 degree angle. The 1/8-inch fragments are badly twisted and seem to have been "blued" by heat. The size of the crater suggests that the fuze might have functioned prematurely.

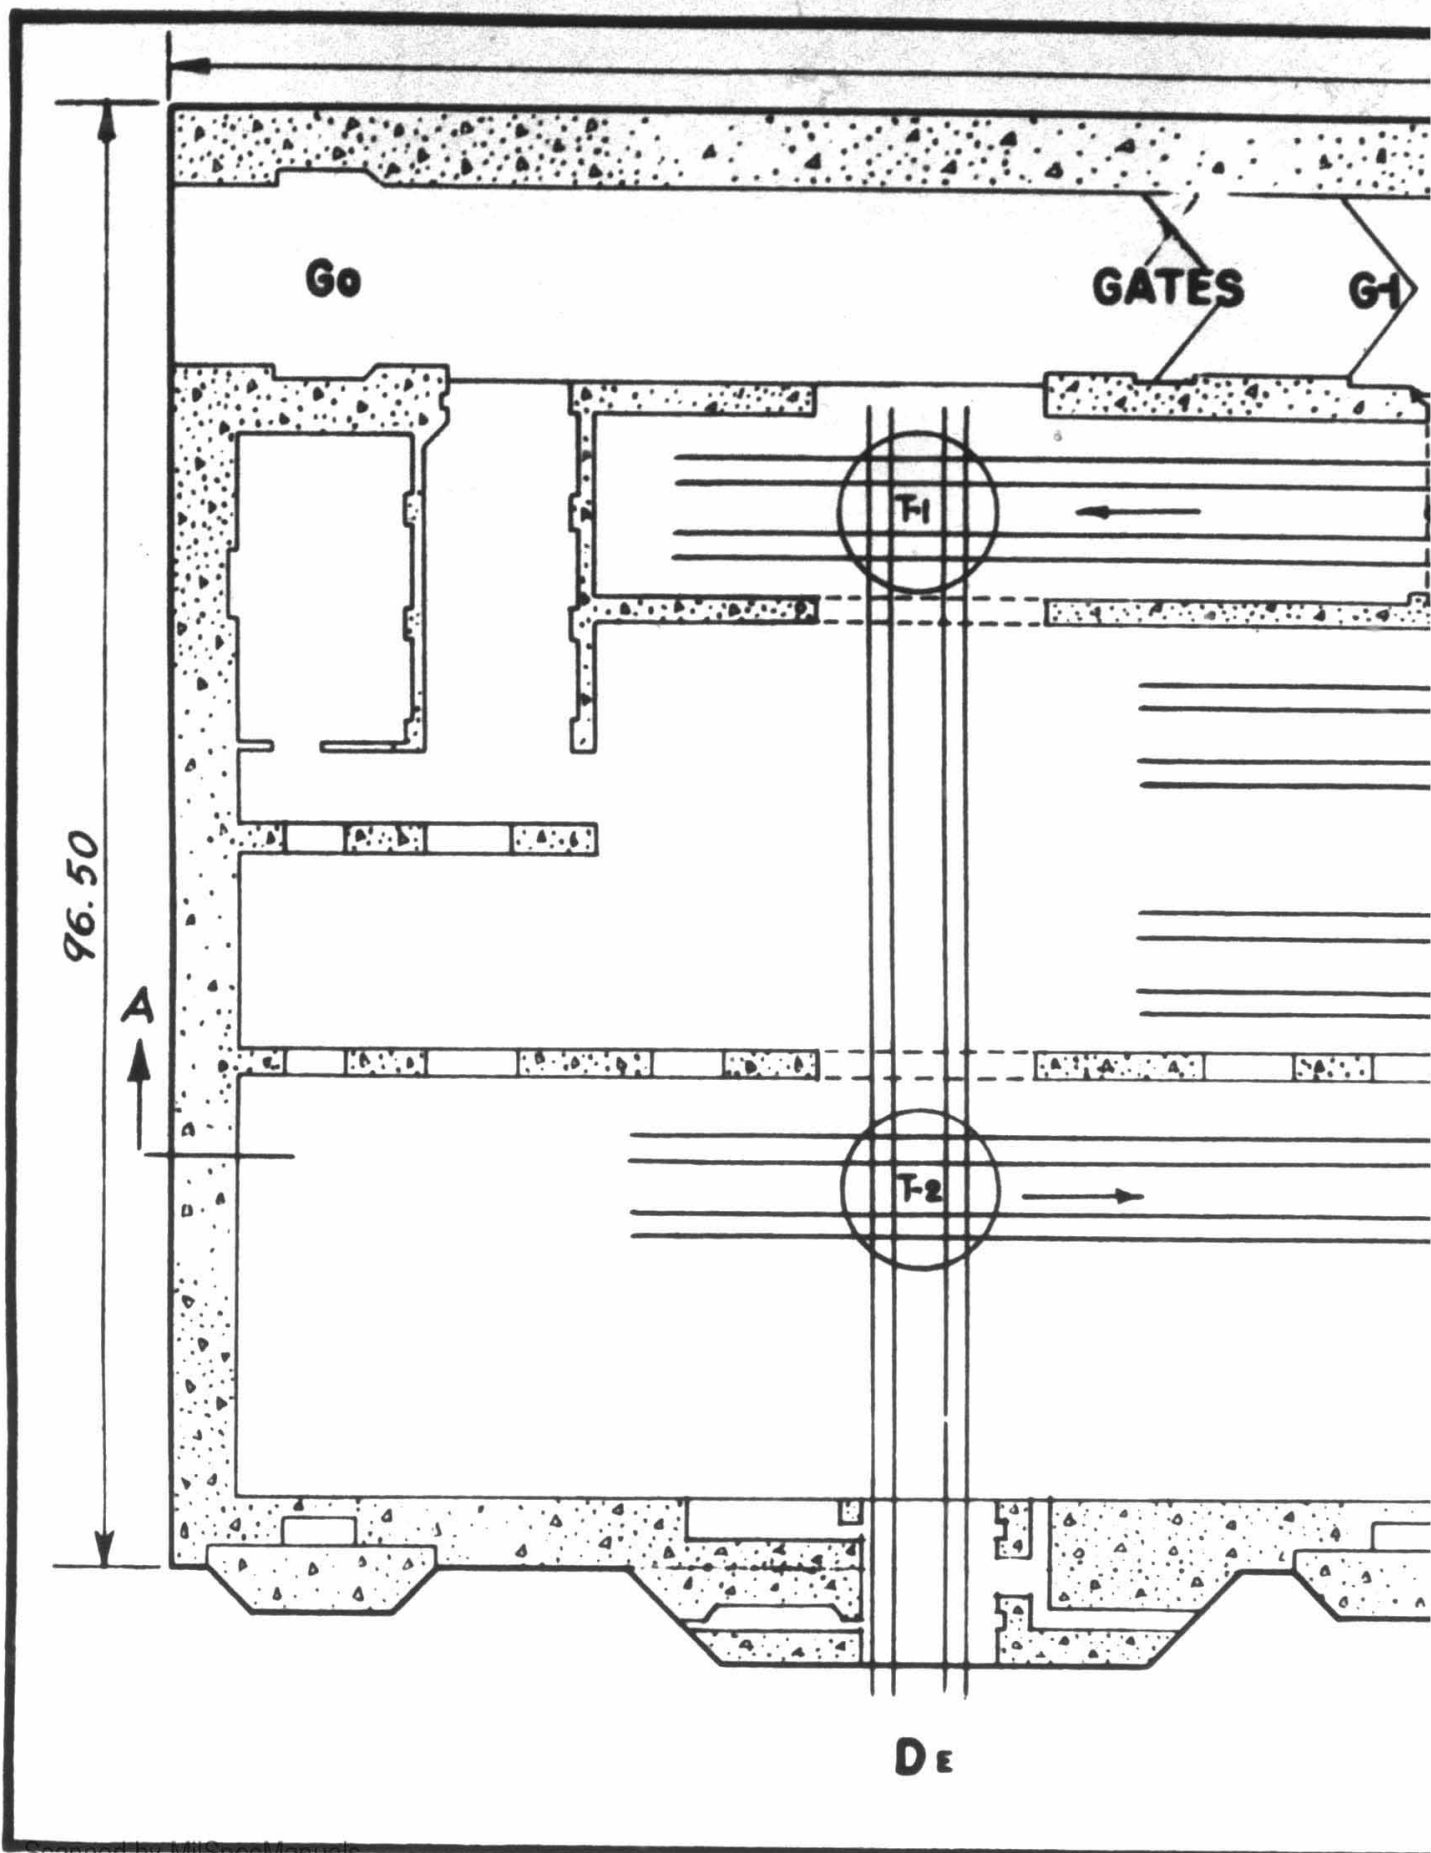
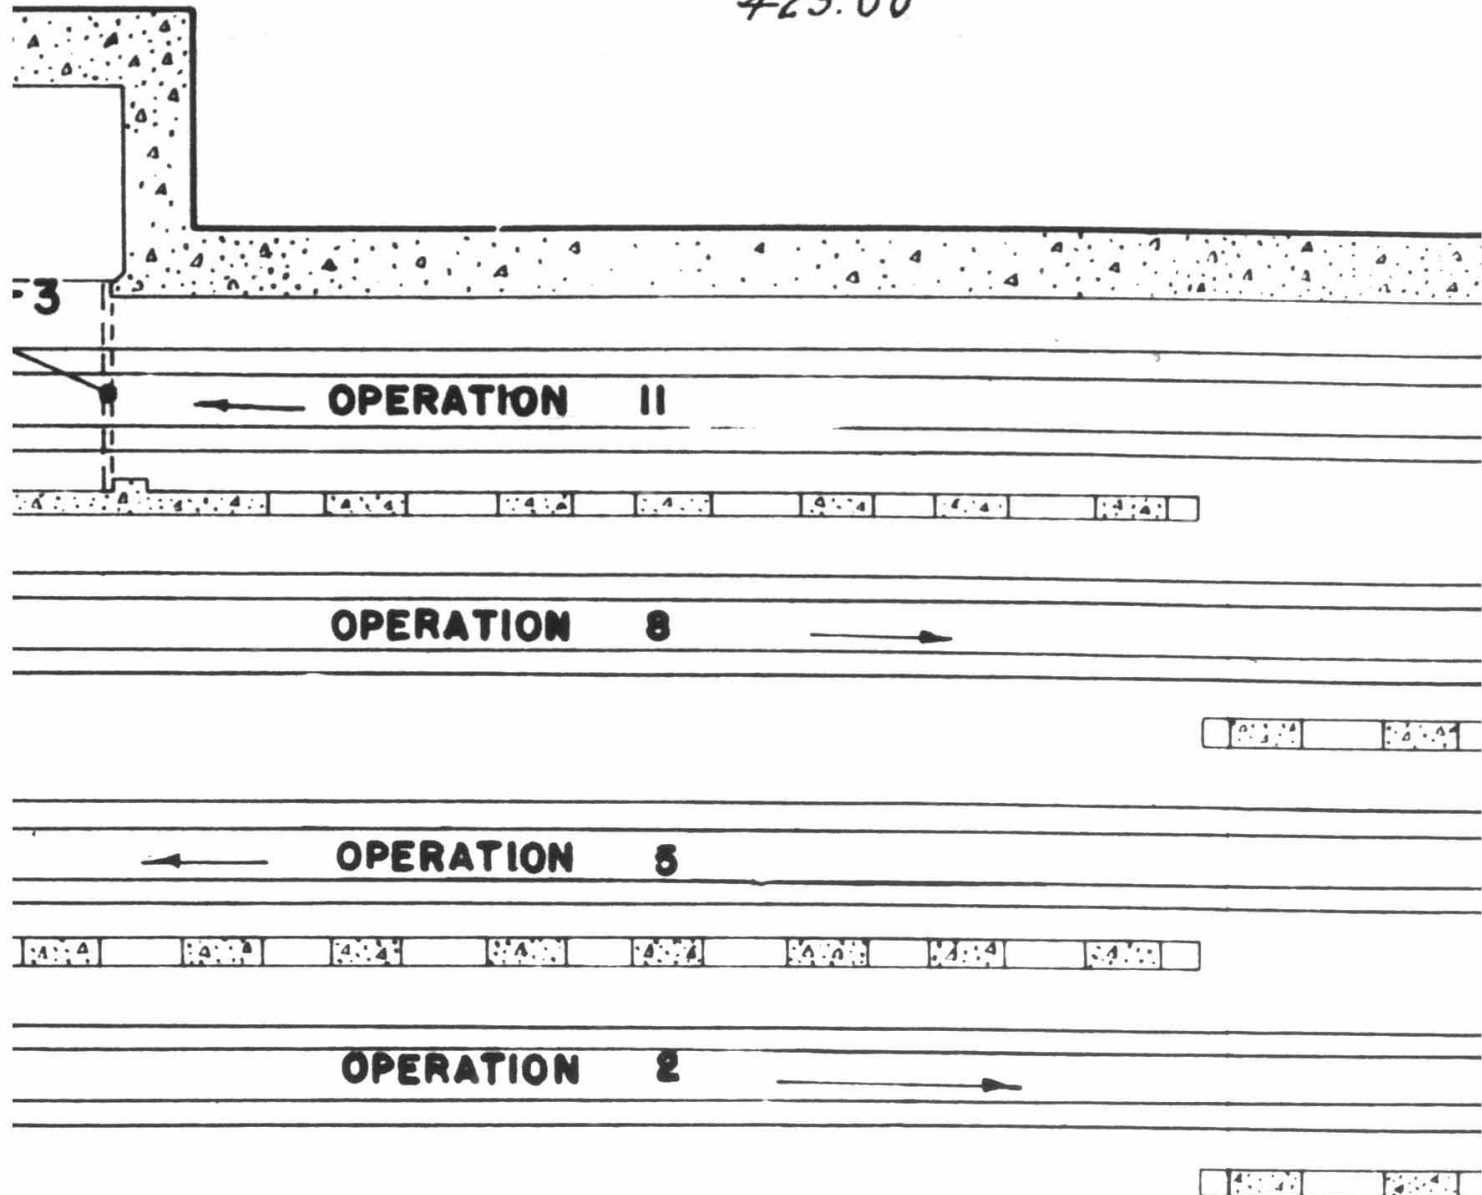
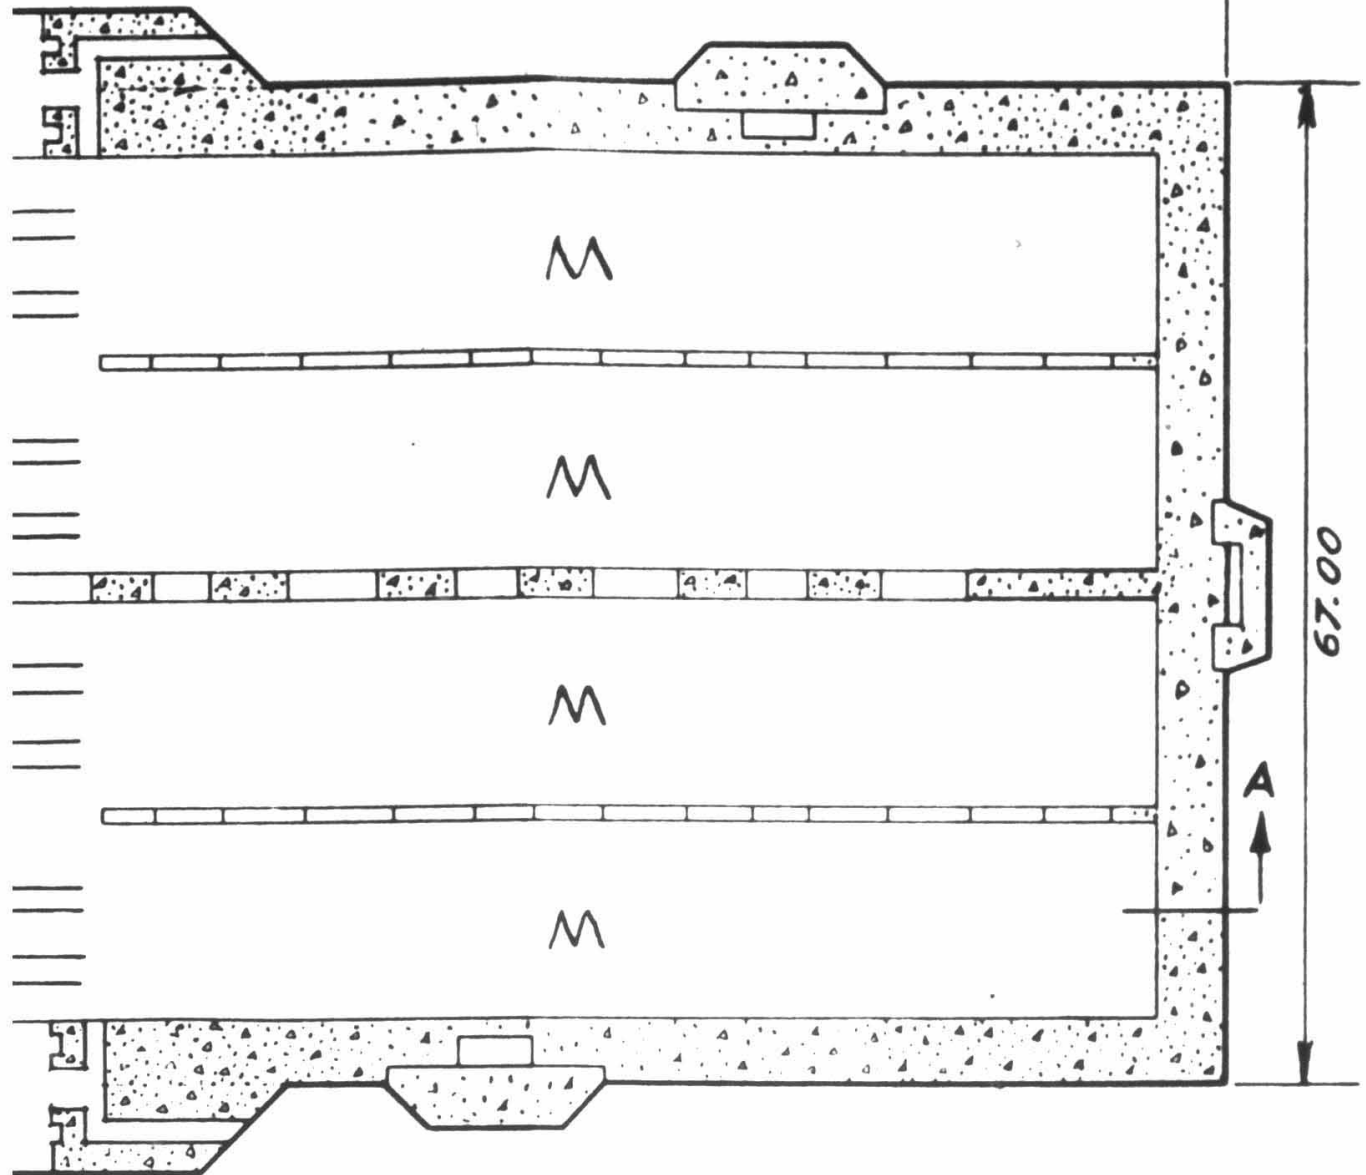
## FLOOR PLAN OF SUBMARINE FACTORY

8. A barge was to enter VALENTIN by Gate G. (Exhibit B) A 200 ton crane was to pick up the section and put it on a bogey standing on Turntable T-1. The bogey would then move on a track to Turntable T-2, where a traveling, overhead 200-ton crane would pick up the section and place it in the "ready use" space along the south wall. The bogey would turn at 90 degrees to the left and move along the track. As soon as a train of eight empty bogies were assembled, the 200-ton crane would select a set of eight sections in the "ready use" space and assemble a complete submarine. This train would then move through the building from Stations 1 to 12, during which various operations were carried out until the submarine was ready for launching. At that stage Gates G-1, G-2, and G-3 were closed and space filled with water when the submarine was floated from 12 to 13. (Photo Frontispiece) On reducing the level of the water in 13 to that of the river, G-1 and G would be opened, and the submarine would leave the building. On the raising of G-2, the empty bogies could be used again for transporting sections from a barge to the storage place.

9. The part of the building marked "M" was reserved for machines and shops which were to be installed on three floors, including oxygen and acetylene producing plants, complete electric power stations and various auxiliaries.

10. Apart from the Water Gate G, VALENTIN has four other doors. Doors "Ds" are scheduled for supplies for the machine shops. "Dd" was to be an emergency door, and "De" provided an exit through which sections could be moved into the open space south of VALENTIN. (Photo 1 and Exhibit A) The space lying to the south of VALENTIN from the SW corner to "Dd" was earmarked for additional building.
